# Post Test Evaluation of HSCT Nozzle Acoustic Liner Subcomponents Subjected to a Hot Acoustic Durability Test

*Michael J. Verrilli and Kuan Lee*  
*Glenn Research Center, Cleveland, Ohio*

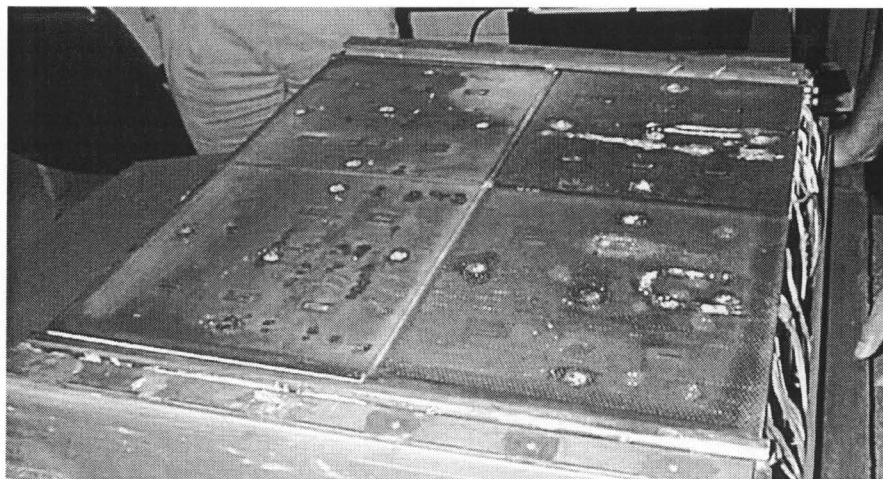
**2.6.2.2.1 CMC Acoustic Tiles** – Figure 22 shows the four tiles after the testing was completed. In this view, the tiles were still installed in the frame used to hold the acoustic liner system to the specimen cart. More detailed views of the tiles after removal are shown in Figure 23. No damage, such as cracks or chips, was observed after a detailed examination of the tiles. The variation in color that can be seen on the hot side in both figures is due to a loss of the black constant emissivity paint and presence of alumina cement used to attach the thermocouples.

Figure 22 – Photograph of the CMC acoustic tiles after completion of the durability test.

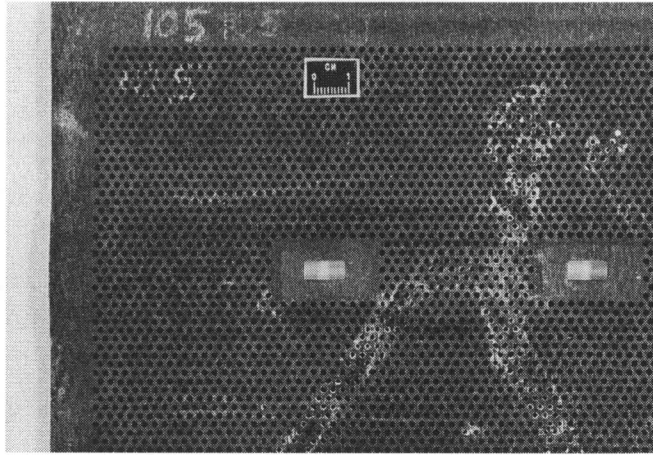
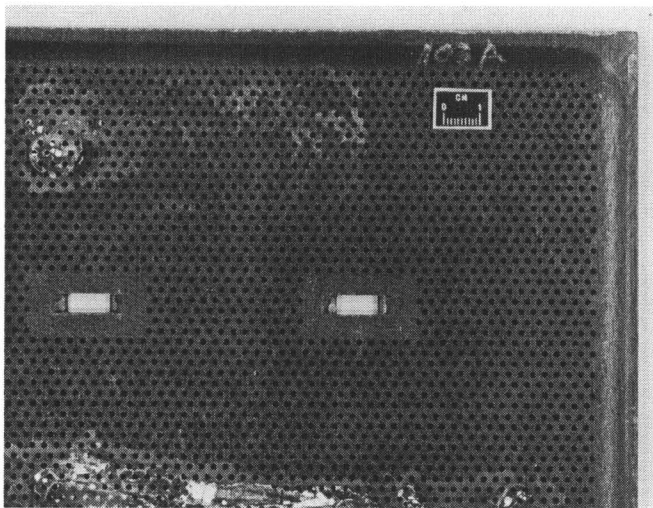
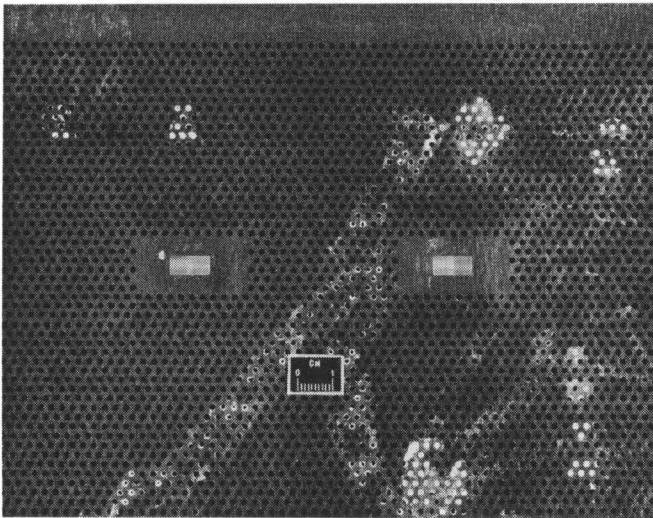
Figure 23 – Views of the CMC tiles after the durability test; a) cold side of tile 105, b) hot side of tile 103A, and c) cold side of tile 109A.

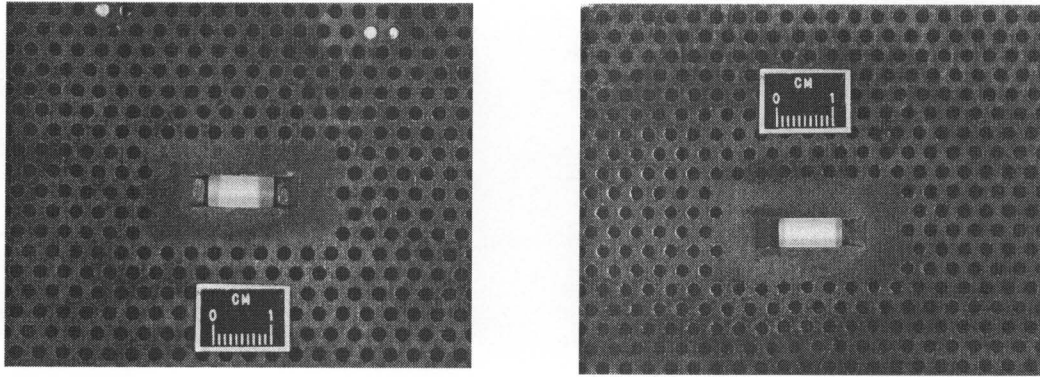
Each fastener hole was examined. Again, no damage, such as cracking or chipping, was found in any hole. An example of the typical condition is shown in Figure 24 for tile DC 111A. As stated above, only four fasteners were installed in this tile, leaving two fastener holes empty in order to evaluate the integrity of a 4-attachment design concept. Figure 24 shows a hole that contained a fastener (Figure 24a) and a hole that was not used (Figure 24b). The lightly colored (white) region in Figure 24a is possibly  $\text{SiO}_2$ , which is present in all the fastener holes that contained a CMC lug during testing. The white regions are not present in holes that did not contain a fastener.

Figure 24 – Fastener holes in tile 111A after completion of the durability test; a) hole that held a fastener, with slight discoloration, b) hole that was not used during the test.

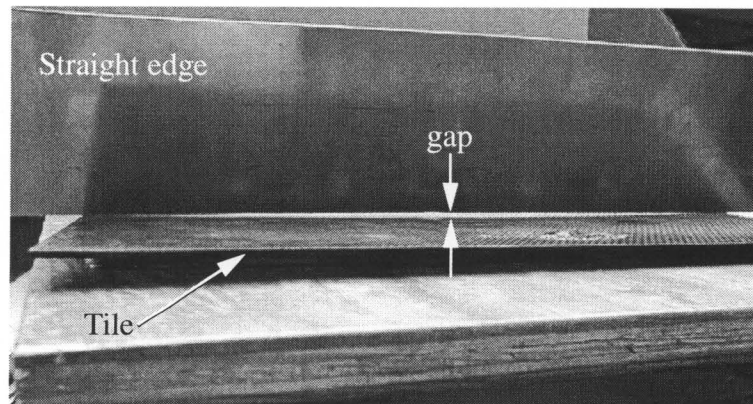
An inspection by the WPAFB personnel after 43 cycles of testing revealed that one CMC tile (DC 105) had shifted and could not be moved back to its original location. The sealing lip on DC 105 would not slide under the two adjacent tiles, DC 109B and DC 111A. Tile DC 105 was then removed from the test and replaced with the spare, DC 103A.

As mentioned above, one tile (DC 105) was replaced after 43 cycles with the spare, DC 103A. A detailed inspection revealed warpage of tile DC 105 (Figure 25). No externally observable damage could be found in this tile. An ultrasonic inspection of this tile was inconclusive and could not detect any damage associated with the warpage. The tile warpage is believed to be the result of impingement of water on the hot tiles when a leak of the test facility's cooling water occurred.

Figure 25 – Edge-on view of CMC tile DC 105, showing the out-of-plane warpage that occurred during the durability test.

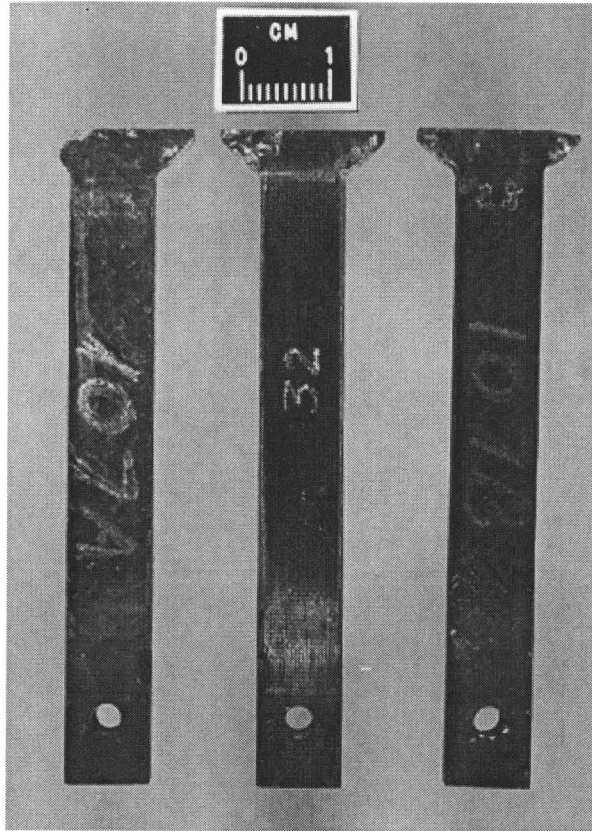
The radiography conducted after the durability test showed cracks and missing material in the head region in ten of the eighteen fasteners. In some cases, this damage could easily been seen with the naked eye (Figure 26). A view of the nature of the cracking leading to this chipping in the head region of the fasteners is shown in Figure 27. This type of damage was also observed during hardware inspections during the test (reference 10).

The fastener damage likely originated in two ways. Damage initiation may have occurred during disassembly process. To remove a fastener, the nut and washer were first removed (Figure 7). Next, the threaded sleeve was removed by pressing out the pin. It is likely that high loads were imposed while pressing out the pin, especially in cases when the pin fit tightly in the fastener hole.

Another possible origin of damage was loosening of fasteners due to relaxation of tension imposed by the belville washer. Vibration of the fastener in the CMC panel attachment hole may have occurred in the loosened fasteners. Periodic inspections (as noted in Appendix I) during the hot acoustic test indicated that the torque on the fasteners was typically less than the initial 10 in.-lb. value.

Figure 26 – Typical damage observed in the CMC fasteners.

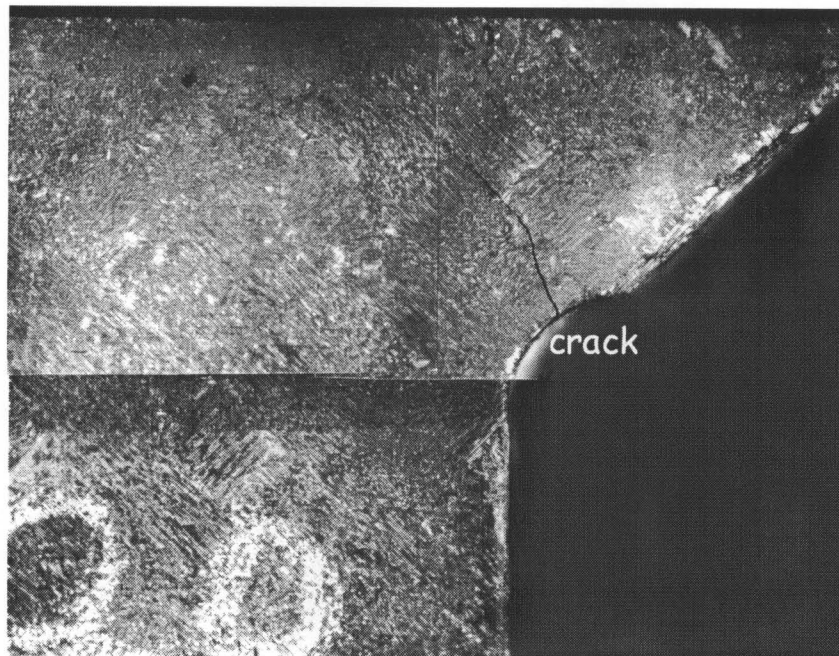
Figure 27 – Photograph of fastener #20, showing a crack in the head of the fastener.

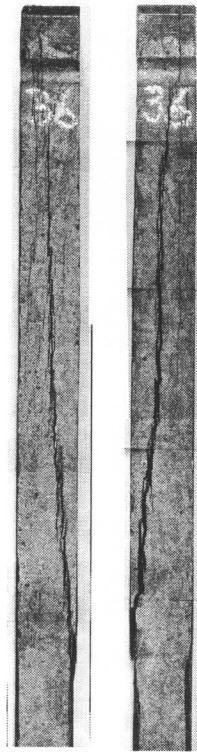
Interlaminar shear failure occurred in one fastener (Figure 28). This fastener was removed after the completion of ambient testing. Even in the damaged state, the fastener carried the required axial load. A detailed analysis (reference 17) revealed that the damage was caused by a combination of misalignment and torsion loading, which probably occurred during the assembly and disassembly processes.

Figure 28 – Interlaminar damage in a CMC fastener, viewed by photographs of both edges of the fastener.

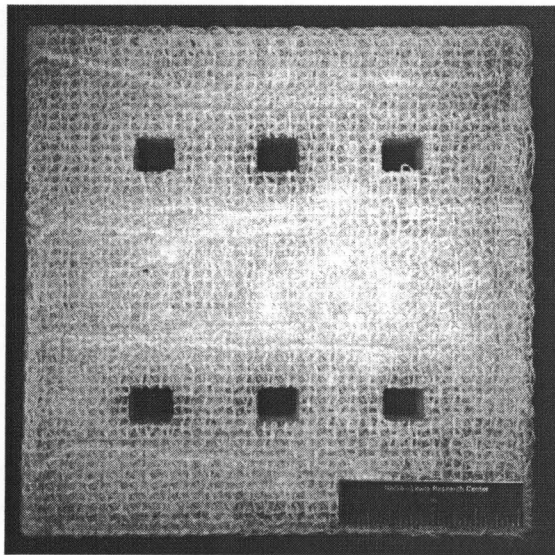
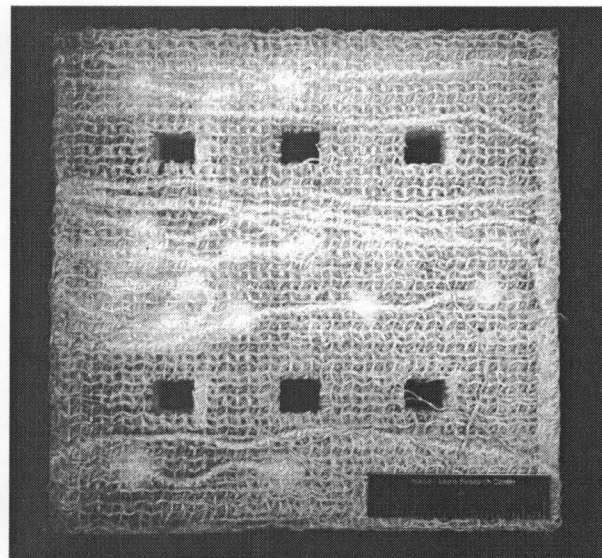
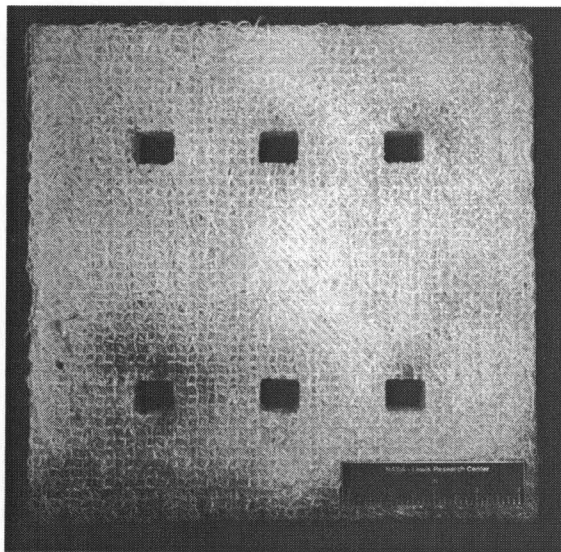
**2.6.2.2.3 Acoustic Absorber** – Figure 29 shows the four acoustic absorbers that were tested. The three T-foam panels had some discoloration, particularly on the hot side and outside edges, but no obvious damage could be seen. The lines seen on the hot side of the T-foam panels are regions where the thermocouples attached to the cold side of the CMC tiles contacted the T-foam.

Figure 29 – Post-test view of acoustic absorber panels; a) hot side of T-foam panel 1973-26, b) hot side of T-foam panel 1973-41, c) cold side of T-foam panel 1973-30, d) cold side of Ultramet SiC foam.

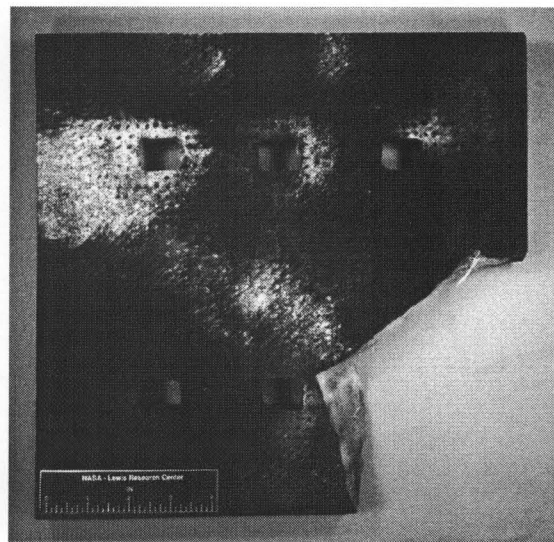
d)

Damage was observed in the Ultramet SiC foam bulk absorber. A section of the SiC foam was missing (Figure 29). The white deposits on the SiC foam absorber are insulation from the TPS (the TPS will be discussed in the next section). Some SiC powder was found in the CEAC after 43 cycles of testing and more extensive damage of the Ultramet absorber was noted after 52 cycles. Also, the fastener holes increased in size relative to the initial dimensions. Abrasion between the  $\text{Si}_3\text{N}_4$  spacers and the SiC foam caused this damage.

Additional TPS damage occurred in the region of the TPS that was under the SiC foam absorber (Figure 33). Degradation of the Ultramet SiC foam bulk absorber probably led to the development of this damage. The hole in the TPS foil shown in Figure 33 exists in the region initially covered by the missing section of the SiC foam. Also, no HSA ceramic paper remained in the TPS adjacent to this hole and some was deposited on the SiC foam (Figure 29d).

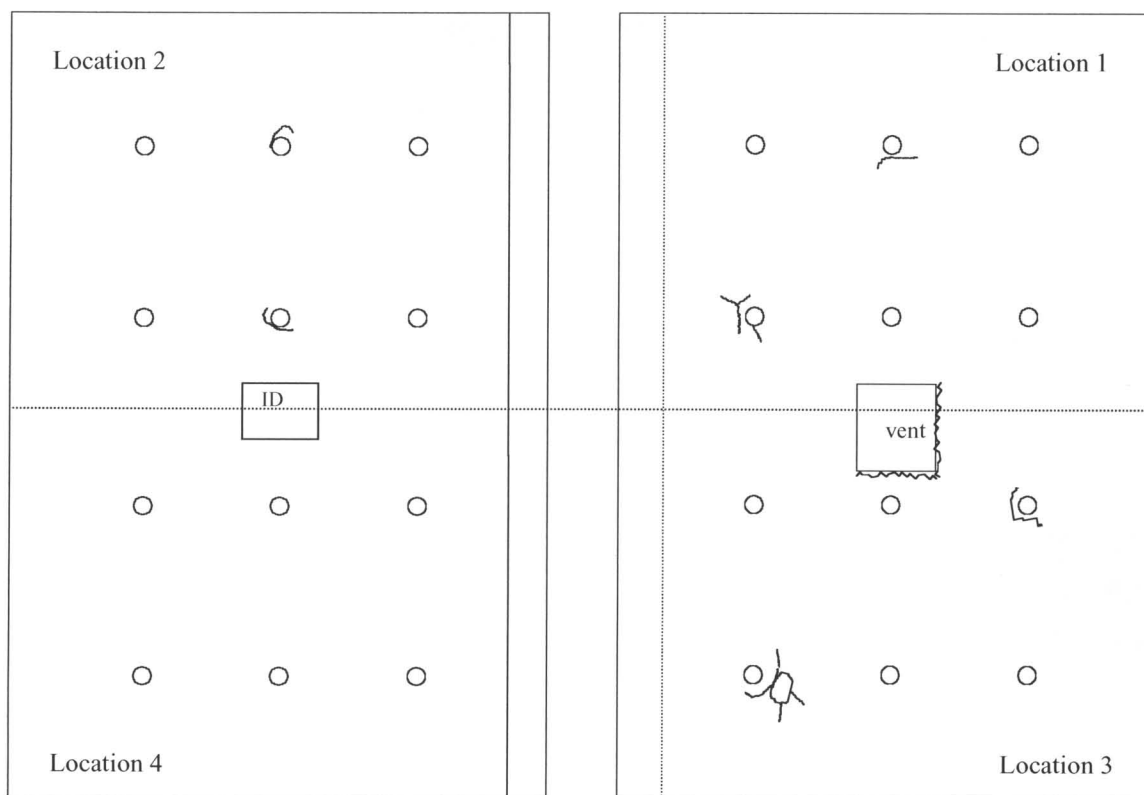
**2.6.2.2.4 Thermal Protection System** – A schematic showing the hot side of the two TPS panels is shown in Figure 30. This figure also indicates the position of the TPS relative to the tiles and the acoustic absorbers (see Figure 3). Cracking in the TPS was observed around the attachment holes (Figure 31) and under a vent on the hot side. No cracks were present on the cold side. The cracking appears similar to that observed in the TPS after the preliminary test conducted in the CEAC (reference 18). One difference is that fewer cracks exist in the panels tested during the durability test (6) than in those panels subjected to the preliminary test (10). In both cases, the cracks seem to have initiated adjacent to the weld region between the surface foil and the grommets. Imprints of the  $\text{Si}_3\text{N}_4$  spacers are present in the TPS subjected to durability test (Figure 32). These imprints exist around most attachment holes on the hot side.

The cause of the most of the cracking in the TPS panels was likely related to loosening of the CMC fasteners. The loosened fasteners enabled vibration of the  $\text{Si}_3\text{N}_4$  spacers against the TPS outer foil, resulting in the imprints (Figure 32) and cracking of the outer foil on the hot side (Figure 31).

Figure 30 – Schematic of cracking on the hot side of the TPS panels after the hot acoustic durability test.

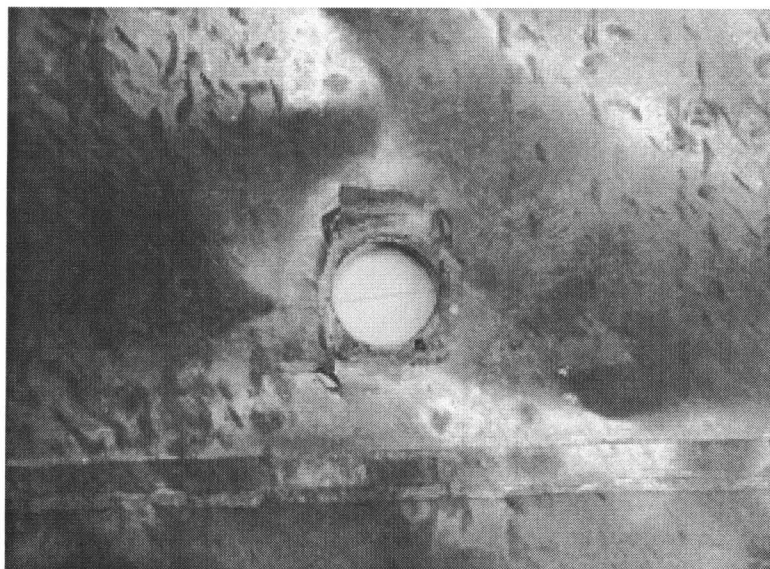
Figure 31 – Cracking observed in the TPS after the hot acoustic durability test.

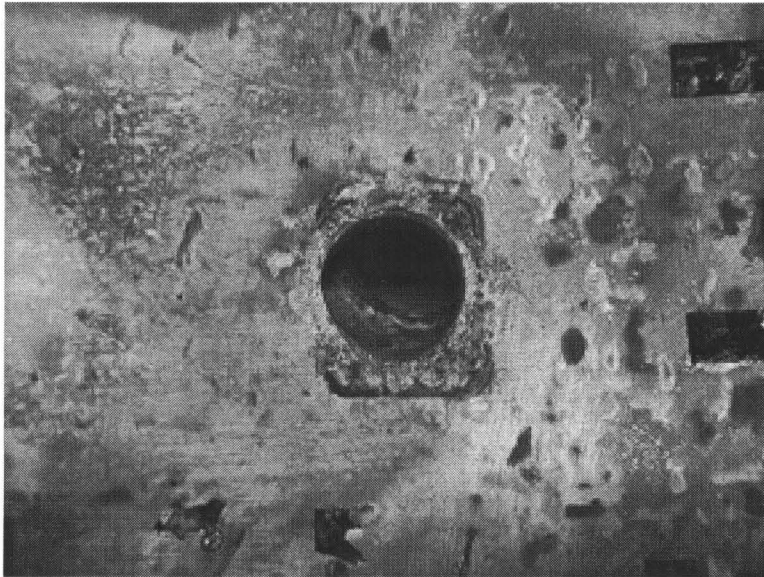
Figure 32 – Imprint of a  $\text{Si}_3\text{N}_4$  spacer on the hot side foil of the TPS subjected to the durability test.

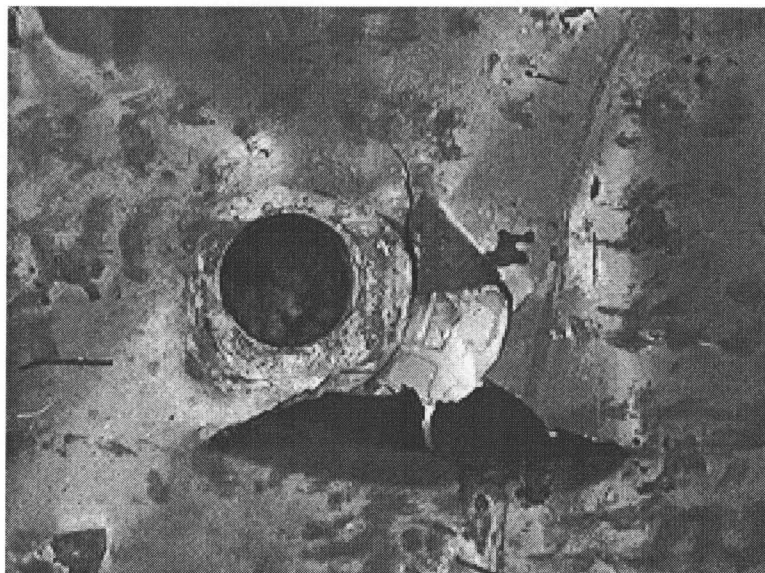
Figure 33 – Damage of TPS serial number 1 in the region that was under the Ultramet SiC foam.
